CIRCULAR—NO. 120

RUSTLESS PIPE FOR WAR AND PEACE

BY
FREDERICK SQUIRES

REPRINTED FROM THE OIL AND GAS JOURNAL
VOL. 44, NO. 13, AUGUST 4, 1945

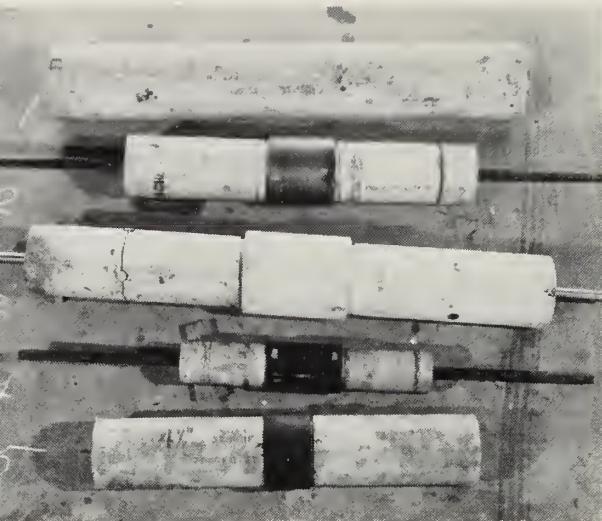
Fig. 2—(Left) A section of asbestos cement pipe at 1, joint 4 at 2, joint 6 at 3, joint 3 at 4, and joint 5 at 5

Bursting.—A section of 5-in.-i.d. 200-lb. pipe shown in Fig. 2 (top) was tested at the factory to 800 psi. without failure. The ultimate strength is 1,100 psi.

Collapse.—The section of pipe shown in Fig. 2 (bottom) was subjected to 2,000 psi. compression without failure at the Bradford Supply Shop at Robinson, Ill. The section shown in Fig. 2 (top) was tested to 1,750 psi. without failure. This specimen consisted of two sections of 4½-in.-i.d. 200-lb. asbestos-cement pipe connected by a pitch fiber coupling. The pipe was prepared by machining the ends of the pipe, placing a rubber gasket at each end, and fitting them with metal caps connected through the pipe with a rod which was tightened with nuts on each end of the rod where it extended through the cap.

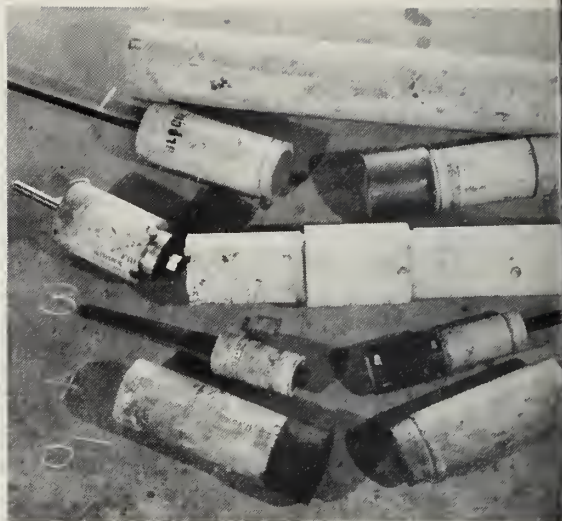
Fig. 3—(Right) The joints after being tested to failure. Points of failure are indicated for each joint in Fig.

Joint No. 3 (see Figs. 2 and 3) failed in the thinnest part of the pipe next to the type-metal mechanical bond at 4,600 lb. The material was low-grade flue pipe and the result is not comparable with the other results described.

Joint No. 4 (see Figs. 2 and 3) failed in the thread at the outer edge of the coupling at 20,200 lb.

Joint No. 6 (Figs. 2 and 3) withstood a pull of 28,700 lb., at which point the pipe pulled apart at the point where the pins holding the rod weakened the pipe.

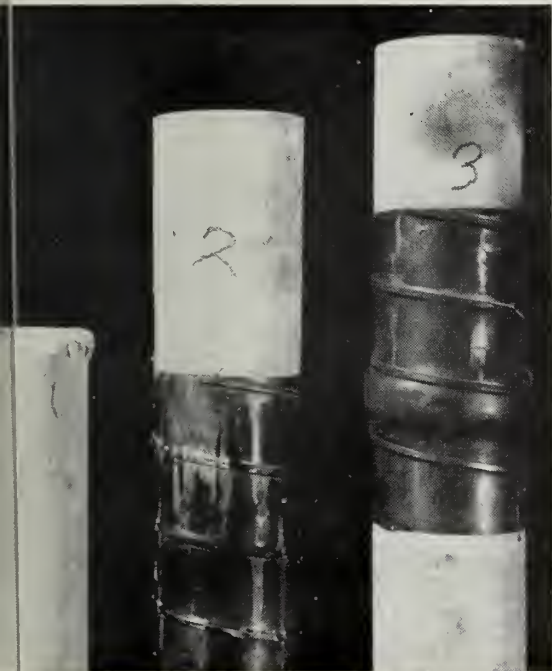
Fig. 4—Joints 1 and 2 (shown also in scale sections on Fig. 1 and a section of similar asbestos cement pipe for comparison. No tension test was made, but compression tests destroyed joint 1 (center) at 21,000 lb. and joint 2 (right) at 18,000 lb. The pipe (left) failed in compression at 2200 lb., showing that the joints weakened the pipe. Fig. 5—(Right) Testing machine in the Talbot laboratory on which all the tests were made. The joint being tested is shown in Fig. 1 as No. 5, the 6-in. pipe coupling

the outer section was run into place. This joint was destroyed in compression at 18,000 lb. Joints 1 and 2 are shown in Fig. 4.

A section of 3-in. i.d. asbestos-cement flue pipe (also shown in Fig. 4) was destroyed in compression in order to compare its behavior with that of the jointed pipe. It failed at 25,200 lb. showing that the joint was weaker than the pipe.

Joint No. 5 (shown on Figs. 1 and 5) went to 12,700 lb., at which point the plug in the end of the pipe pulled out and the test had to be stopped. On a later test, after the plug had been reset, the thread on

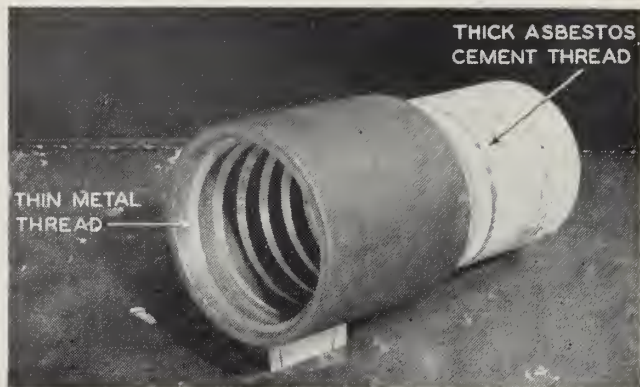
Fig. 10 — A metal coupling the projecting thread of which has a thin section, and asbestos cement pipe the thread of which has a thick section. This is an attempt to proportion the cross-section of each material to its relative strength to resist stripping

cement thread. (Fig. 10). The threads were made by grinding (Fig. 11). The smaller section of the metal presents greater strength to resist stripping than the greater section of pipe, as was shown in the test wherein the joint failed in the pipe thread. This idea should be incorporated in the design of any metal coupling for nonmetallic joints of pipe.
